## Crew Injury – Steam Burns

### What Happened?

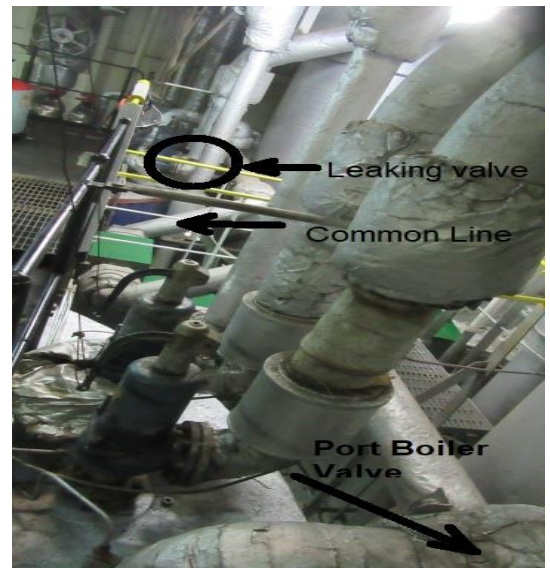
Work permits for energy Isolation and Enclosed space entry had been completed, and Lock out-Tag out had been done - lashings and tags placed at the isolation valves.

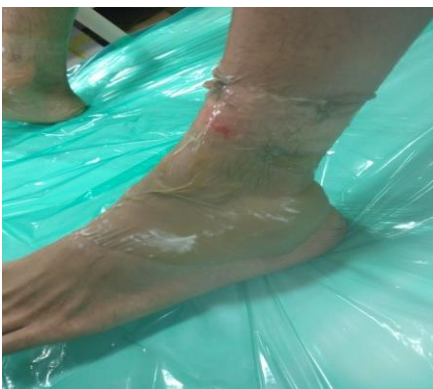
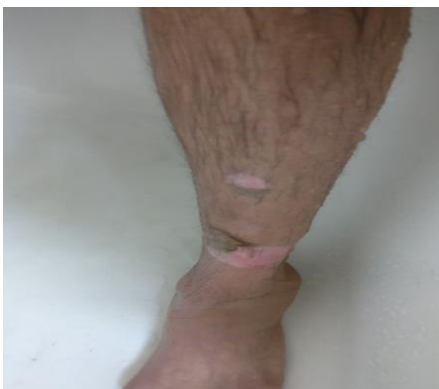
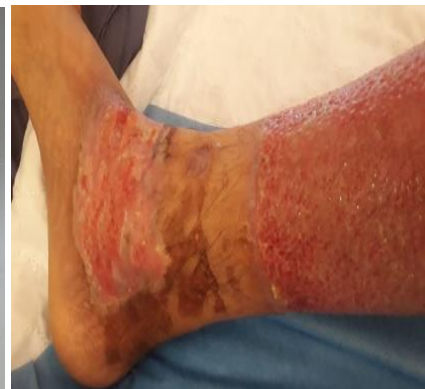
The Oiler reacted quickly to the sudden ingress of steam but still took about 15 seconds to escape from the boiler. He suffered significant steam burns to his legs – injury to his face and hands was averted due to the PPE and face mask being worn. **This could have been far worse, and the Oiler is lucky to be alive....**

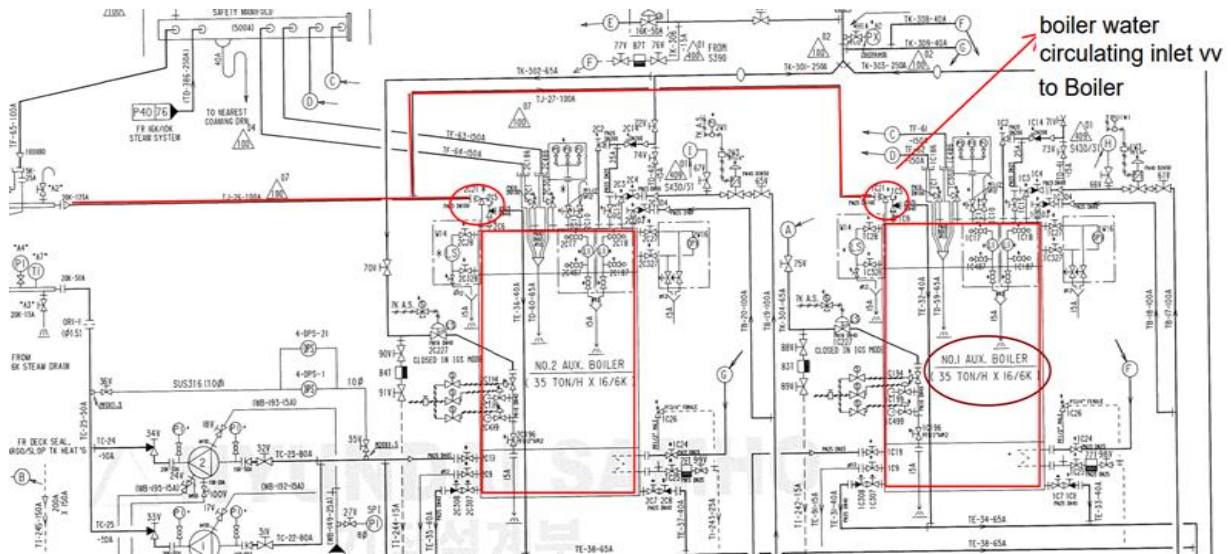
## Boiler Valves and Piping Diagram

Simultaneously, the duty engineer was instructed by the bridge to make the main engine ready for sailing. Main engine heating was required so the 4th Engineer was instructed by the Chief Engineer to open the steam on the port boiler. This valve is on a common line with the starboard boiler and has a single valve segregation to the starboard boiler.

To open the valve, the LOTO tag and lashing had to be removed. This was not questioned by the 4th Engineer nor by the 3rd Engineer who was acting as linkman for the Starboard boiler. The 4th Engineer opened the valve and then steam entered the starboard boiler, due to the valve passing on the starboard boiler.

- Inadequate Supervision by the Senior Officers onboard
- Lack of appreciation to increased risks through simultaneous operations
- Lack of communication between the team working in the engine room
- Perceived pressure - there was a hurry to activate the port boiler and have the engine ready prior to the pilot embarking.
- Bypassing the Company's isolation control procedures - Lock out/Tag out was removed prior to completing work, placing colleagues in danger.
- Ineffective stop-work-authority implemented onboard – colleagues saw the LOTO being removed.
- JSA/Risk Assessment did not consider single valve segregation between the steam line and the boiler where people are working. As a result, positive isolation of the steam line valves was not done (single valve - no blank used).
